# Shoreline Study and Water Quality Assessment of Danford, McAuley and Shea lakes

A report presented to the Lakes Association of Kazabazua  
by the Agence de bassin versant des 7 (ABV-7)

October 2016

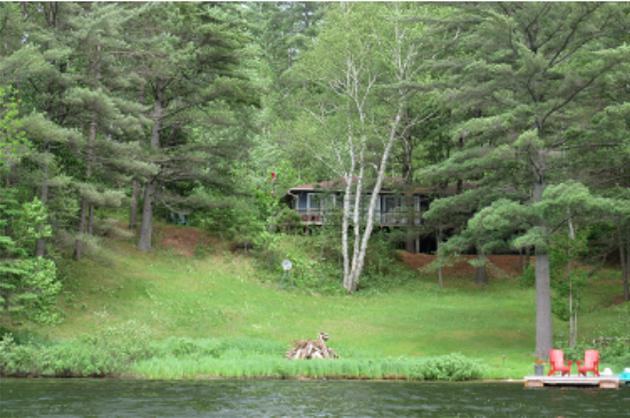
Natural vegetation cover on Shea Lake shore in percent

On June 6, 2016 during our on-site visit to Shea Lake, we observed that its shoreline was in relatively good condition, considering the number of existing cottages (44). A few properties have lawns down to the waterline, but in many cases, a vegetation strip is maintained along the shoreline. It should be noted that some of these strips of vegetation, although preferable to lawns, remain insufficient to protect the shoreline effectively.

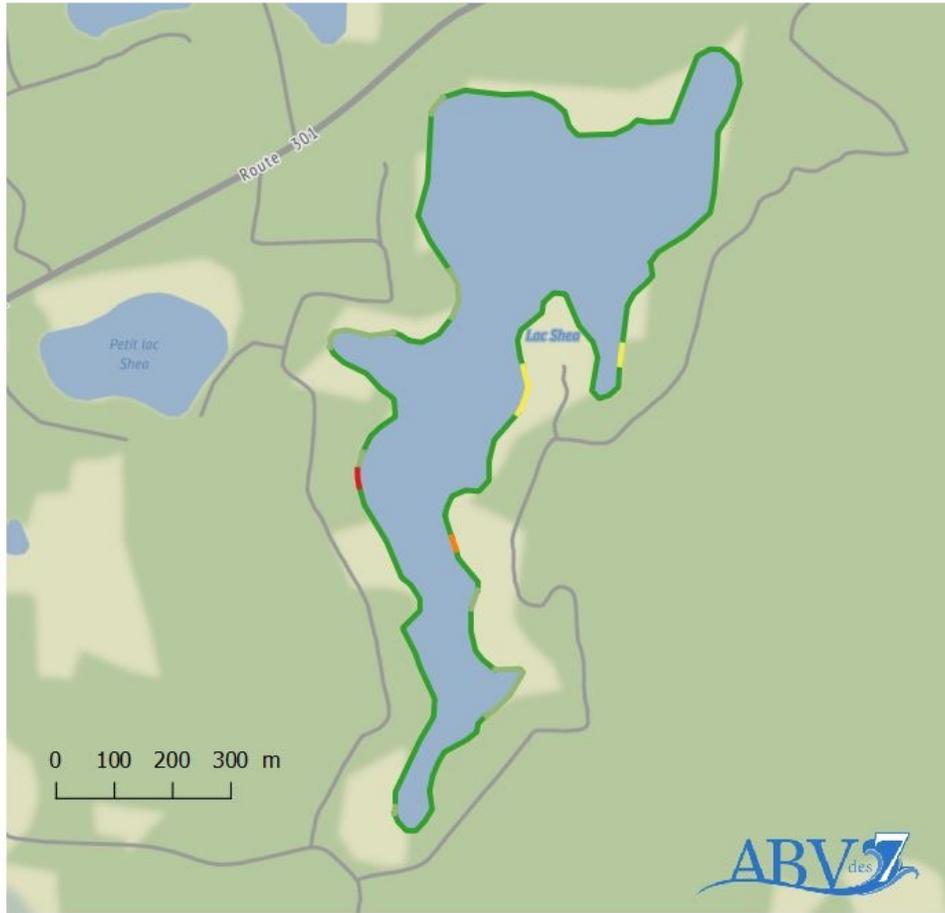
## Shea Lake shore deterioration in percent

We did not note any major deterioration of Shea Lake’s shore. We observed only one building in close proximity to the water line (a permit was most probably issued to the owner for this apparently recent construction). We also saw an older cottage erected on the shore strip, but the vegetation cover is sufficient there. There are no zones of erosion on Shea Lake, except on one property where a strip of shrubs was planted to capture part of the sediments washing into the water.
