Shoreline Study and Water Quality Assessment of Farm, McConnell, Little Shea, Lyons et Little Danford lakes

A report presented to the Lakes Association of Kazabazua
by the Agence de bassin versant des 7 (ABV-7)
(Mai 2018)

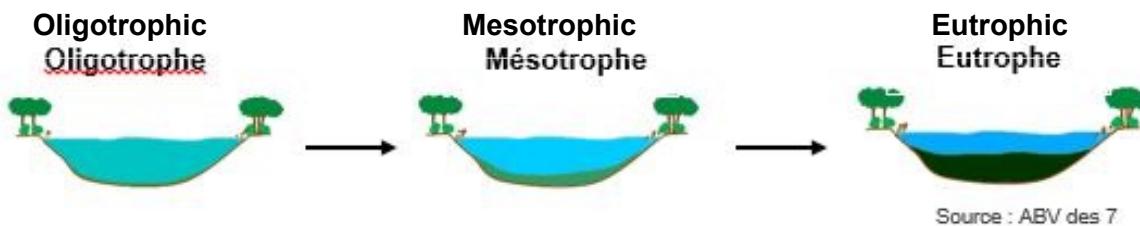
Fig. 1 - The three trophic states of a lake: (I) oligotrophic, (II) mesotrophic and (III) eutrophic

Keeping a lake at the first (oligotrophic) stage is important in order to prevent its premature aging.

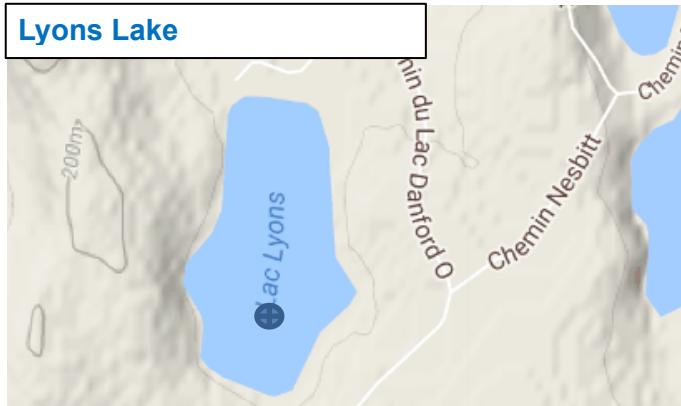
Fig. 2 - Location of greatest depth in Little Shea, Farm, and Lyons Lake

No bathymetric maps were available for the five lakes. We used a depth finder to locate their deepest spots:

Lake	Greatest Depth (m)	Coordinates
Farm	24	45° 55' 58,25" N 76° 8' 6,883" O
McConnell	26	45° 56' 10,49" N 76° 7' 56,454" O
Little Shea	24.1	45° 55' 55,456 N 76° 7 27,1 " O
Lyons	24.8	45° 58. 8.852 76° 8' 20.907"
Little Danford	14.3	45° 56' 20.115" N 76° 7' 12,5" O

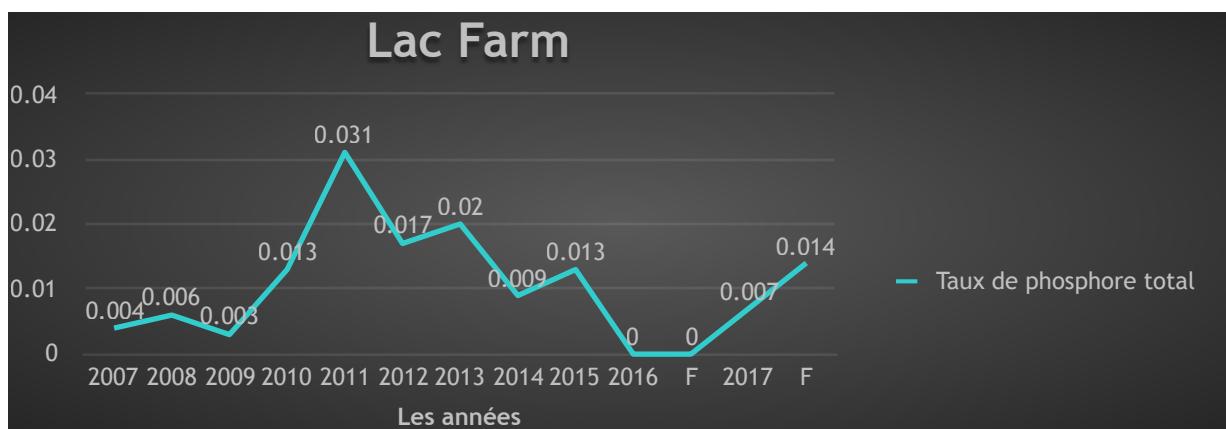
Fig. 5 — Total Phosphorus levels (mg/L) in Farm Lake over 10 years (2007-2017)

Over the years, all samples (taken by LAK alternatively in the Spring or in the Fall of each year) show relatively stable phosphorus levels which remain way below the threshold of eutrophication (0.03 mg/L), with the exception of 2011. This peak might have been caused by unfavourable weather conditions or a leak from a faulty septic system. The situation would be worrisome if the levels were repeatedly high from one year to another, but this is not the case here. Phosphorus levels in Farm Lake are characteristic of an oligotrophic lake.

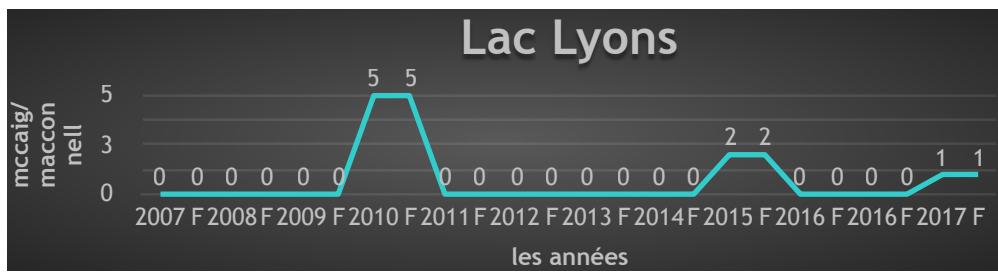
Fig. 19 — *E. coli* concentrations in Lyons Lake (CFU/10 mg) over 10 years (2007-2017)

E. coli concentrations in Lyons Lake have varied over the years, and it is difficult to say whether they are the result of natural processes or caused by human activity. However, they remain way below the levels at which swimming should be prohibited (200/100 mL). Like in the other four lakes, the 2014 peaks observed are probably weather-related. Lyons Lake water is therefore of a very good quality in this regard.

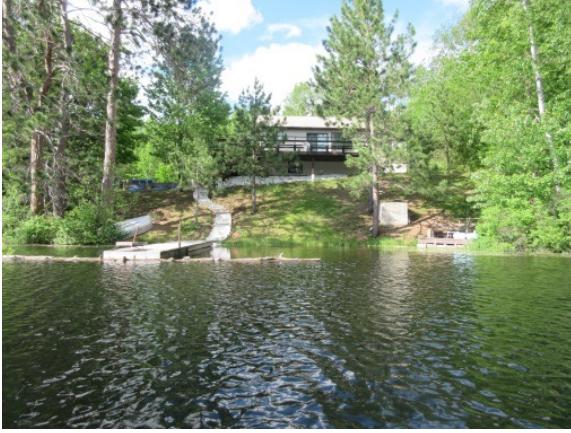
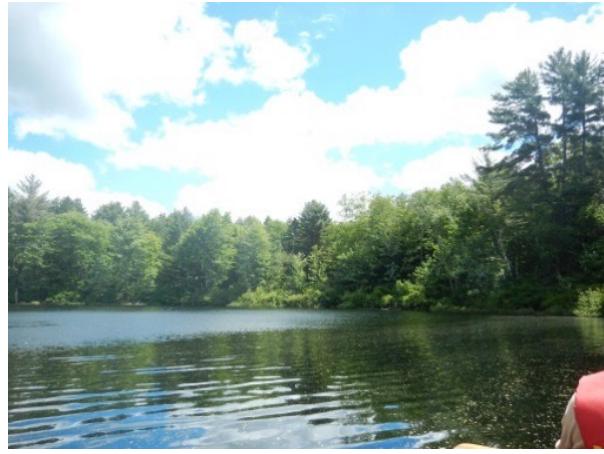
Fig. 28—Examples of the two categories of land identified on the five lakes

<p>Category 5 (Land used for buildings, etc.)</p>

<p>Little Shea Lake</p>	<p>Category 1 (No use of the land=vegetation throughout)</p>

<p>Farm Lake</p>
---	--

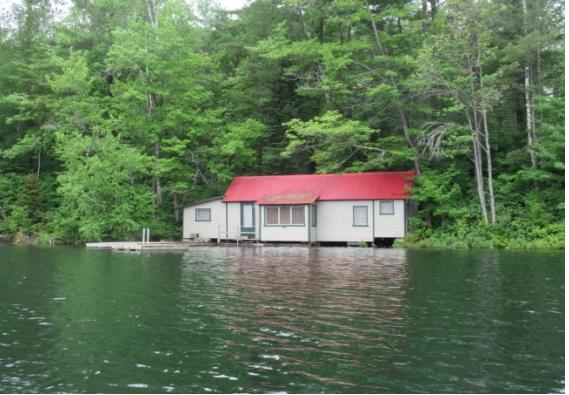
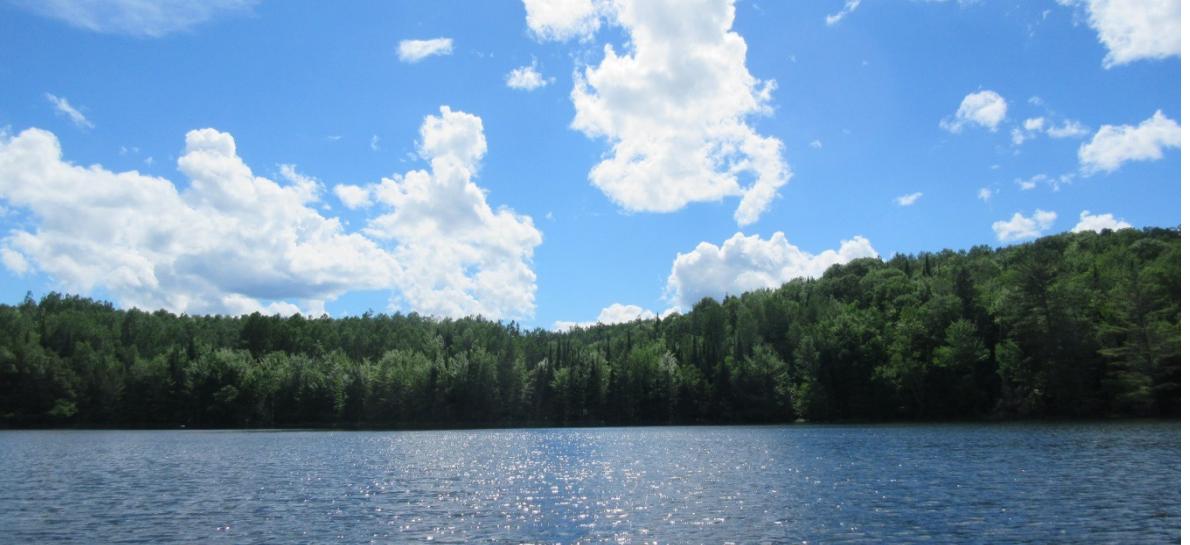
Fig. 9—Examples for the three categories of human-made changes identified on the five lakes' shorelines

Presence of Inert Materials	Modified Cover (Ornamental Vegetation)

Little Danford Lake	McConnell Lake
Full Natural Cover

Lyons Lake

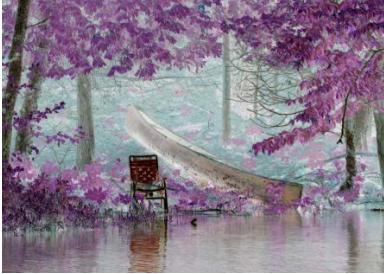
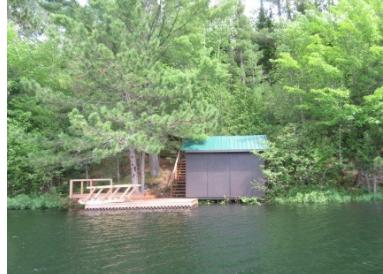
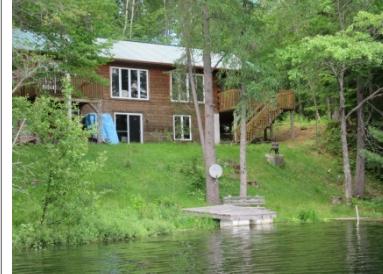
There are relatively few human-made changes to Lyons Lake's natural shoreline, except in one case where the percentage of deterioration reaches 60%-80%: too many trees have been cleared, and old structures (docks, etc.) were left abandoned, which is problematic. We also noted a few old structures scattered elsewhere on the lakeshore, e.g. a few sheds situated directly on the shoreline, a few old retaining walls, piles of garbage or old boats abandoned and in ruins. They are an eye sore and can be a source of pollution. Together these disturbances represent 2% of the total shoreline, and corrective measures could easily be applied. If the overall percentage of deterioration remains low it is solely because 77% of the shoreline remains covered with natural vegetation.

Old boat and chair abandoned on the shoreline	Shed too close to the water line	Insufficient vegetation cover on this grassy area

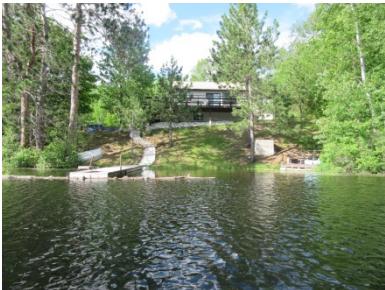
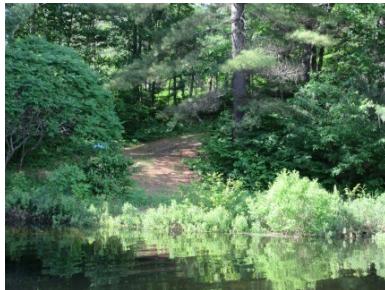
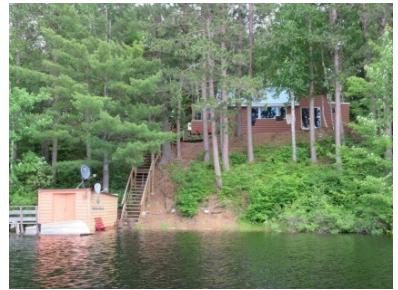
Fig. 43 - Examples of inadequate human-made changes to the shoreline on Little Danford Lake

Excessive clearing of shoreline	Boat launch area on a slope, creating erosion and runoff	Excessive clearing of shoreline, with building directly on the waterline
